City of New Orleans MMG #6183-CNO

Materials Management Group, Inc. (MMG) was contracted by the City of New Orleans Mayor's Office of Coastal and Environmental Affairs to conduct a lead investigation on painted surfaces and in surface soil at Desmare Playground, located at 3456 Esplanade Avenue, New Orleans, LA 70119.

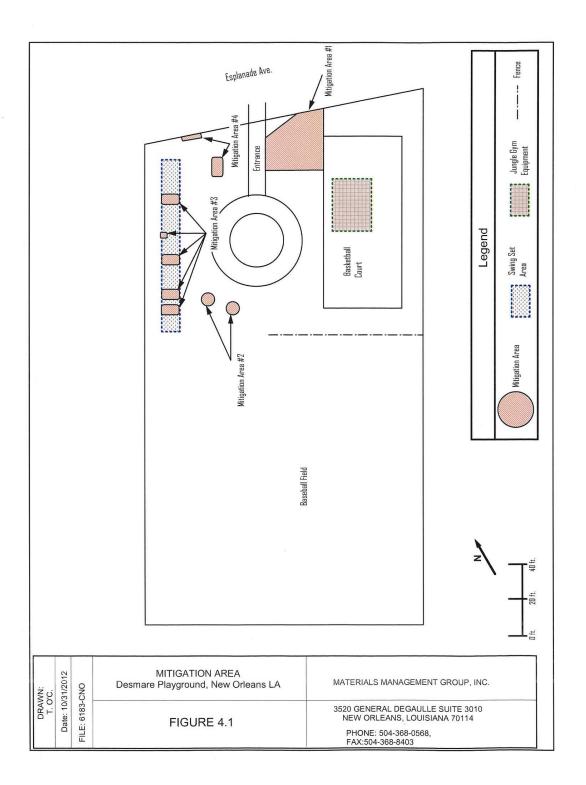
Figure 1: Areas to be Mitigated

A total of 30 soil samples were collected from various locations. The soil lead results ranged from <40 mg/kg (or ppm) to 4,500 mg/kg. After examining the aerial distribution of the sampled soil areas, elevated lead soil areas were limited to the following:

Bare soil area to the east side of the park's entrance, yard and fence line (240 - 560 mg/kg);

- Bare soil area to the west side of the park's entrance, yard and fence line (95 - 820 mg/kg);
 - Bare soil around the swing set play area (400 4,500 mg/Kg);
 - Bare soil area between the swing sets and play area (510 690 mg/kg);

Based on the findings, there are areas in the playground that exhibited soil lead levels exceeding the current USEPA and LDEQ soil lead standard. MMG recommends that mitigation of these areas be made to remove lead hazards that pose a risk to the young children using this playground. The areas to be mitigated are included in Figure 1. The mitigation procedures are included in Table 1 with the estimated costs.

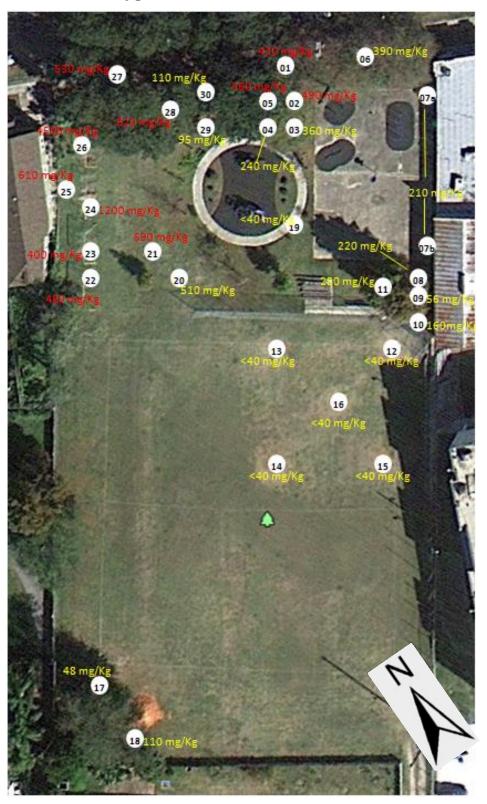
Figure 3.1 Desmare Playground Lead Concentrations in Bare Soil Areas

A total of thirty soil samples were collected. The soil lead results are summarized below in Table 3.1. The soil lead results ranged from <40 mg/kg (or ppm) to 4,500 mg/kg. The results are also shown on the sample location drawing to provide an aerial distribution of lead in soil, as illustrated in Figure 3.1.

The soil lead results ranged from <40 mg/kg (or ppm) to 4,500 mg/kg for all collected samples. By examining the aerial distribution of elevated soil areas, the elevated lead soil areas were limited to the following:

- Bare soil area to the east side of the park's entrance, yard and fence line (240 - 560 mg/kg);
- Bare soil area to the west side of the park's entrance, yard and fence line (95 - 820 mg/kg);
- Bare soil around the swing set play area (400 4,500 mg/Kg);
- Bare soil area between the swing sets and play area (510 690 mg/kg);

Please refer to Figure 3.1 for the aerial distribution of lead contaminated soil.
